# CUNNINGHAM ROOF SURVEYS

## INDUSTRIAL ROOF SURVEY

### ILLUSTRATIVE SAMPLE REPORT

| Report reference | CRS-SAMPLE-IND-001 |

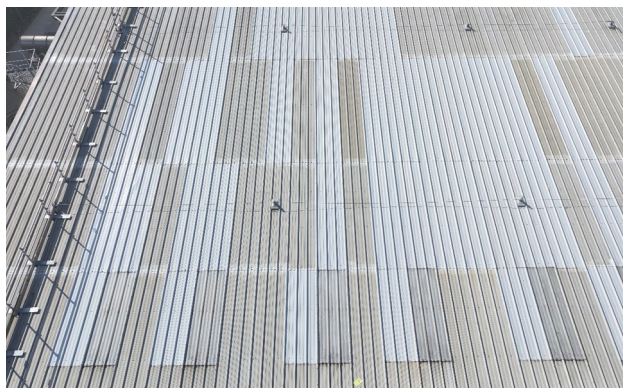
*Rooflight runs showing uneven transparency, contamination and previous localised interventions.*

- The profiled metal roof coverings appear broadly continuous, with no widespread displacement visible from the inspection imagery.
- Several rooflight sheets are heavily discoloured and have reduced light transmission.
- Localised corrosion and coating breakdown are visible along selected sheet laps and fastener lines.
- Previous repair or replacement areas are visually apparent and should be checked for compatibility and watertightness.
- Rooflight fragility should be assumed unless confirmed otherwise by suitable documentation and inspection.

Condition 3 for deteriorated rooflights and active cut-edge corrosion. Other roof covering areas are Condition 2 and require planned maintenance.

| Ref | Location | Finding | Potential consequence | Recommended action | Priority |
|---|---|---|---|---|---|
| D01 | Rooflights | Heavy contamination and local edge deterioration. | Water ingress, reduced daylight and fragile-sheet hazard. | Replace affected sheets and reseal perimeters. | High |

Undertake a contractor-led close inspection of rooflight perimeters, laps and fixings. Replace deteriorated rooflights where cleaning would not provide a durable result. Prepare and treat corroded sheet edges using a compatible system following surface preparation and manufacturer guidance.

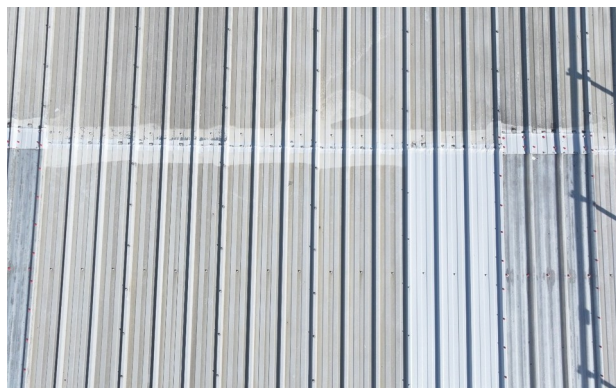
*Sheet lap detail showing exposed fasteners and early-stage corrosion at the cut edge.*

| Ref | Location | Finding | Potential consequence | Recommended action | Priority |
|---|---|---|---|---|---|
| D02 | Sheet laps | Cut-edge corrosion and coating breakdown. | Progressive corrosion, perforation and leaks. | Prepare and treat exposed edges using a compatible system. | High |

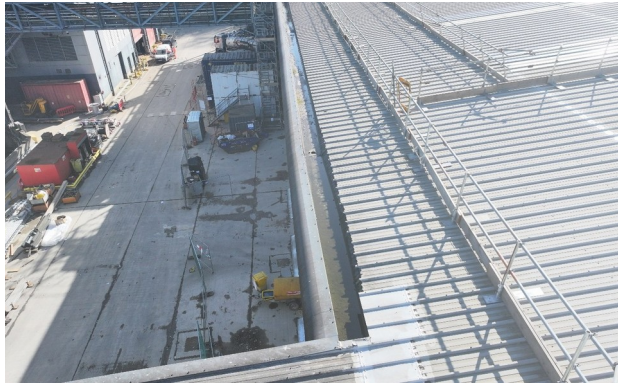
*Perimeter gutter viewed from above; local debris and restricted maintenance access are visible.*

- The inspected gutters appear generally continuous but contain localised debris and organic growth.
- No evidence of a consistent gutter-guard system was visible in the inspected areas.
- Long gutter runs and adjoining roof sections increase the consequence of local blockages.
- Drainage outlets and hidden sections could not be fully assessed from aerial imagery alone.
- Overflow during heavy rainfall may cause water ingress at roof junctions or accelerated corrosion to adjacent sheets.

Condition 2 - planned cleaning, local repair and routine inspection required.

Clear accessible gutters and outlets, then inspect for splits, failed joints, corrosion and standing water. Introduce a documented inspection frequency linked to seasonal leaf fall and the site environment. Consider guards only where they will not obstruct maintenance or reduce flow.

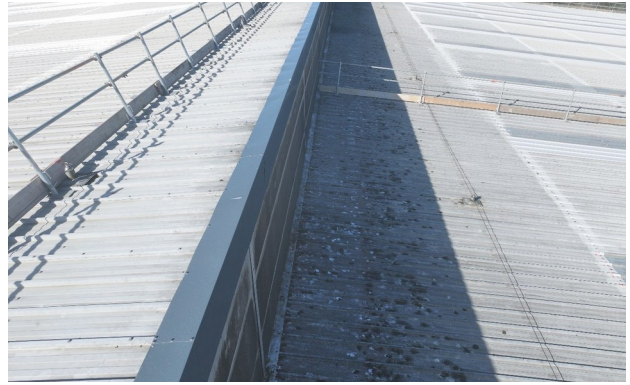
*Long valley or box-gutter run between roof sections requiring routine inspection and clearance.*

| Ref | Location | Finding | Potential consequence | Recommended action | Priority |
|---|---|---|---|---|---|
| D04 | Gutters | Debris and organic growth within long gutter runs. | Blockage, overflow and water ingress. | Clear, inspect outlets and implement routine maintenance. | Medium |

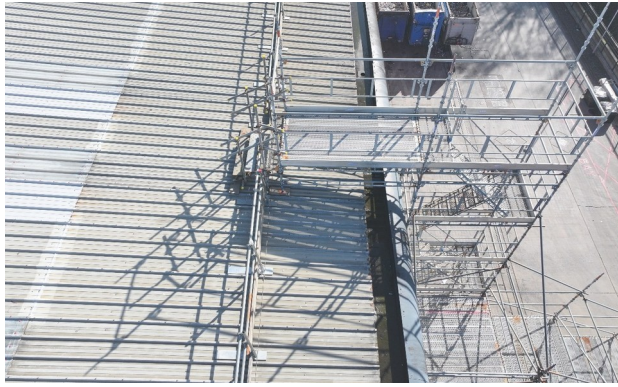
*Temporary scaffold access positioned beside the roof edge.*

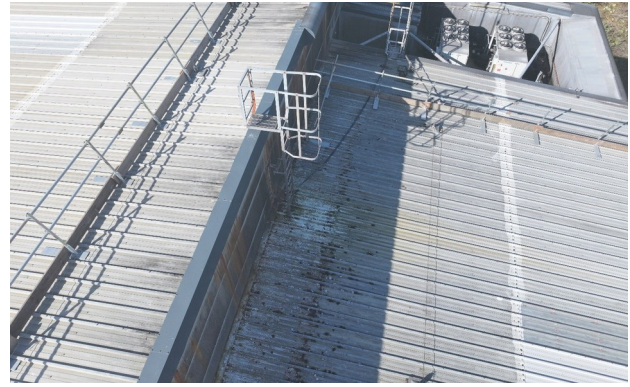
*Fixed ladder and roof-level access arrangement within a restricted roof zone.*

- Roof access is constrained by operational areas, level changes and nearby plant.
- Fixed ladders and roof access points may be suitable for inspection access but may not support delivery of bulky materials.
- Mansafe anchors and lines are visible; however, no current inspection or certification records were available within the sample information.
- Rooflights and some roof sheets should be treated as fragile surfaces.
- Any work at height requires task-specific planning, suitable edge protection or restraint systems, and an emergency rescue plan.

Commission a competent specialist to inspect and certify fixed access and fall-protection systems before use. Prepare a roof access plan showing safe routes, fragile areas, anchor locations, loading points and rescue arrangements. Larger works may require a dedicated loading strategy and additional temporary protection.

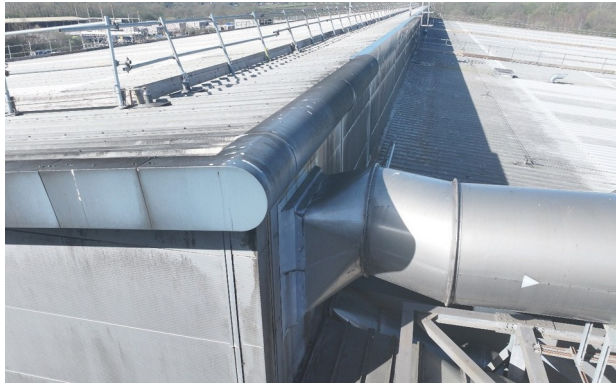
*Raised ridge and adjoining ductwork reviewed for visible joint failure and weathering.*

- Ridge and edge cappings appear generally aligned, with localised weathering and staining.
- Fasteners and joint lines should be checked during close-access maintenance for loosening, failed washers and sealant breakdown.
- Service penetrations create multiple interfaces that require periodic inspection and compatible sealing.
- Debris and contamination are present in sheltered zones and may retain moisture against the roof surface.
- No obvious major displacement was visible from the aerial images, but concealed joint condition cannot be confirmed.

Inspect capping joints, laps, fasteners and penetration seals from safe close access. Remove debris and renew failed sealants using compatible materials. Record each penetration on a roof plan and include it in future maintenance inspections.

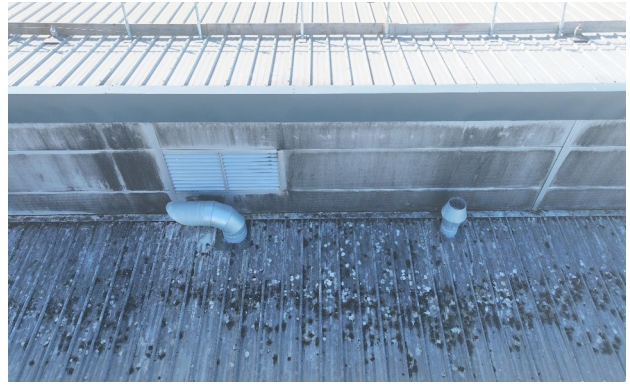
*Service penetrations and adjacent roof area showing local contamination and sealant interfaces.*

| Ref | Location | Finding | Potential consequence | Recommended action | Priority |
|---|---|---|---|---|---|
| D06 | Cappings / penetrations | Local weathering and sealant ageing. | Localised leaks if joints deteriorate. | Close-access inspection and targeted resealing. | Low |

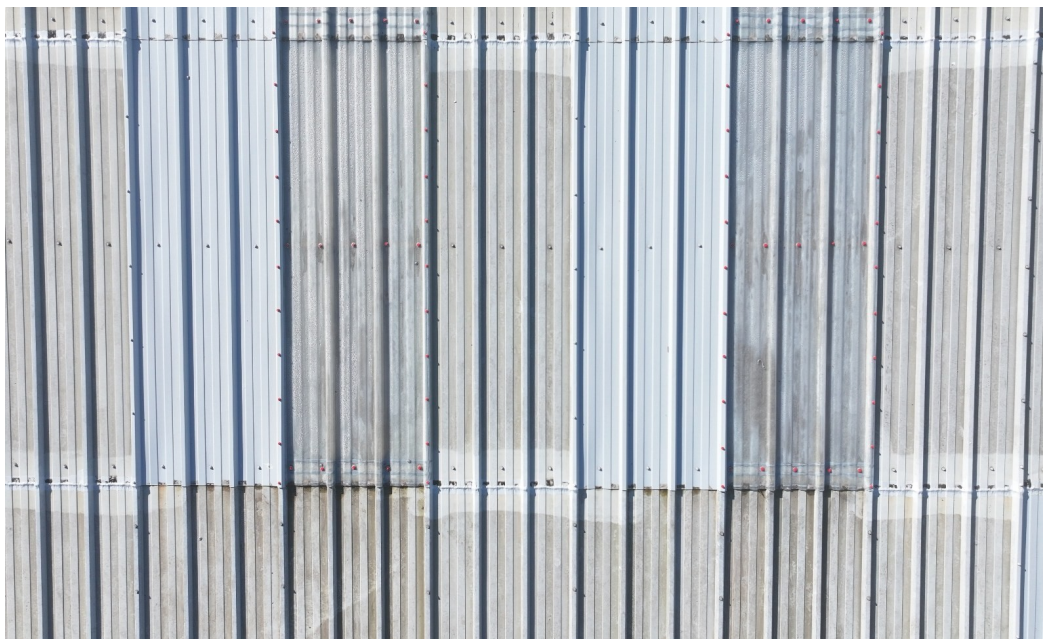
*Example roof-sheet lap used to demonstrate how individual defects may be illustrated and referenced in the final report.*
