# CUNNINGHAM ROOF SURVEYS

# RESIDENTIAL ROOF SURVEY

| Report reference | CRS-SAMPLE-RES-001 |
| Status | Illustrative website sample - not for reliance |

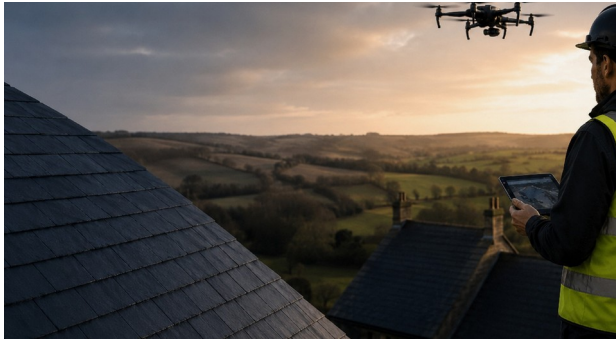
*Principal slate roof slope reviewed for displacement, surface weathering and ridge condition.*

- The slate roof coverings appear broadly aligned, with no widespread displacement visible from the aerial review.
- One localised slipped or displaced slate is visible and may permit wind-driven rain to reach the underlay.
- General surface weathering, lichen and minor edge wear are consistent with the apparent age and exposure of the roof.
- Ridge tiles appear generally aligned, although selected joints show weathering that should be monitored and maintained.
- No slates or ridge units were lifted, so hidden fixing condition and underlay performance cannot be confirmed.

**Condition 2 - localised repair and planned maintenance required.**

Arrange safe close-access inspection of the displaced slate and adjacent coverings. Secure or replace defective units using compatible materials, inspect ridge joints and record all completed repairs photographically.

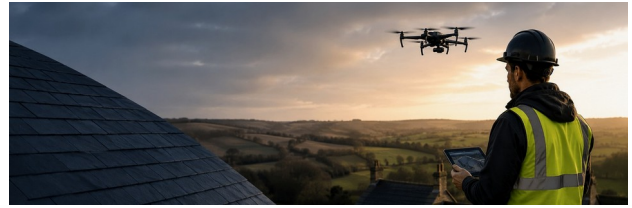
*Annotated roof detail illustrating how visible defects are referenced in a live residential report.*

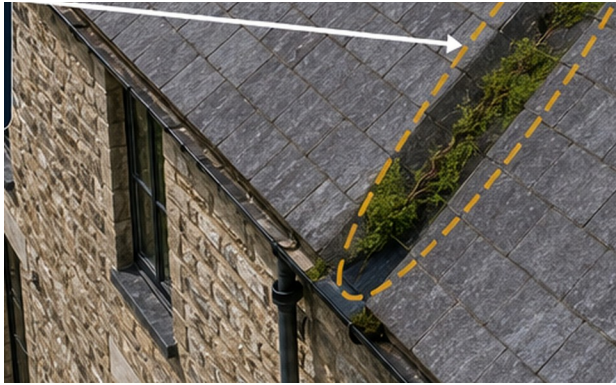
*General roof slope and external junctions reviewed for visible weathering and defects.*

- Roof junctions and visible penetrations create local interfaces that require periodic inspection and compatible weathering details.
- Local sealant ageing and surface weathering may be present at selected junctions and should be checked from close access.
- Verge, eaves and fascia details appear generally serviceable but require routine cleaning and maintenance.
- Fasteners, concealed membranes and hidden junctions cannot be fully assessed from aerial imagery alone.
- No obvious widespread failure was visible, but concealed water paths remain possible where defects are intermittent.

**Condition 1-2 - generally serviceable with targeted maintenance and further close-access checks.**

Inspect rooflight perimeters, penetrations, verge and eaves details from safe close access. Renew failed sealants or flashings with compatible materials and record each repair within the property maintenance file.

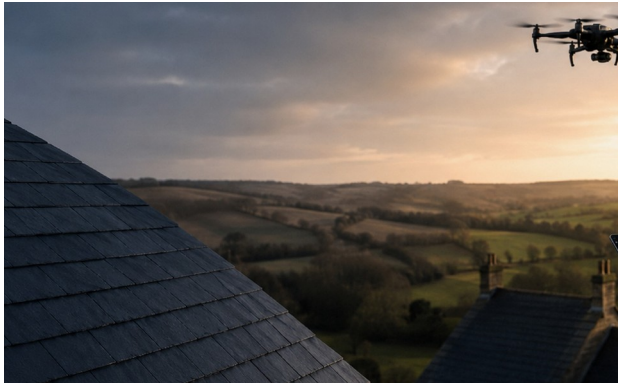
*Pitched roof surfaces should not be accessed without suitable work-at-height controls.*

- The roof is elevated and includes pitched slopes, valleys and potentially fragile components that are unsuitable for unprotected access.
- Aerial inspection reduces the need to walk on the roof but does not remove the need for safe access when repairs are undertaken.
- Ladders, scaffolds, towers or mobile access equipment should be selected and erected by competent persons.
- Any planned work requires task-specific access, edge protection or restraint and an appropriate rescue plan.
