CUNNINGHAM  
ROOF SURVEYS

SAMPLE REPORT

COMMERCIAL  
ROOF SURVEY

| Report reference | CRS-SAMPLE-COM-001 |

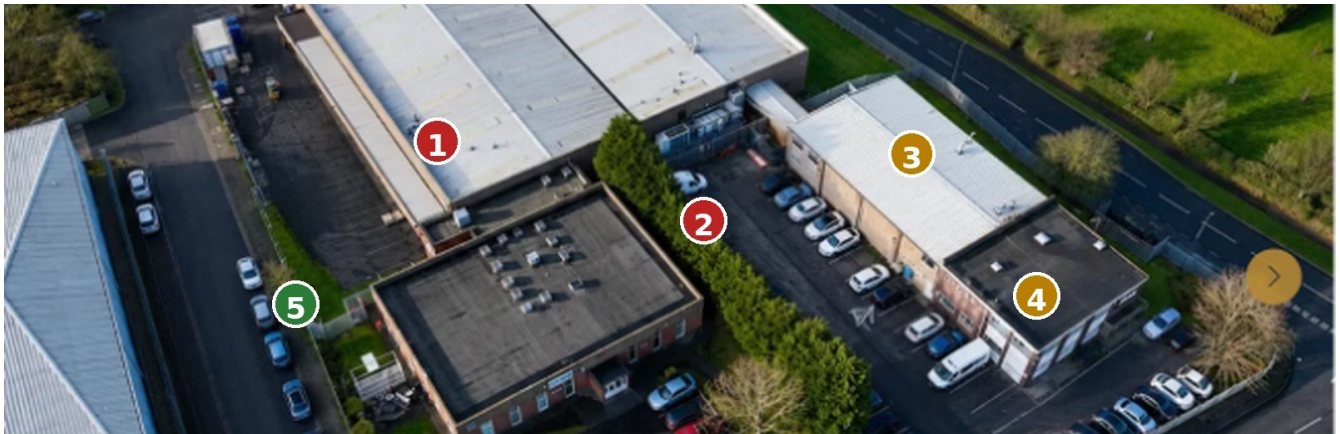
*Illustrative overview with numbered inspection zones. Markers show how findings may be referenced in a live report.*

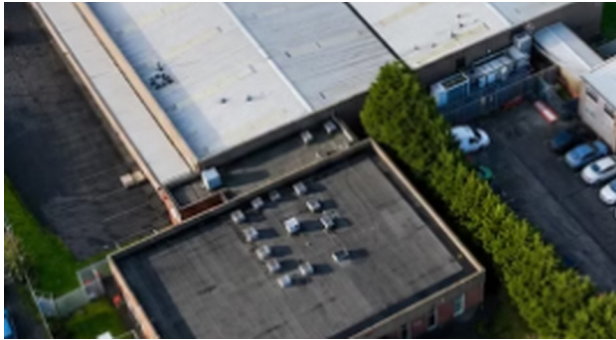
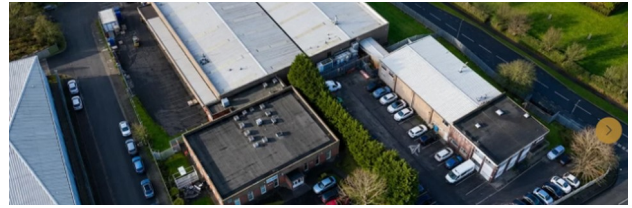
*Lower flat-roof section with roof-mounted plant and perimeter parapets.*

*Relationship between flat-roof sections, profiled roofs and adjoining drainage routes.*

- The flat-roof membrane appears generally continuous from the aerial review, with localised weathering and surface variation.
- Several roof-mounted items create vulnerable interfaces at kerbs, upstands and penetration details.
- Localised areas may retain water where falls or outlets are restricted.
- Parapet cappings and perimeter flashings require periodic inspection for loose joints, failed seals and wind-driven rain entry.
- No intrusive inspection was completed, so the condition of the deck, insulation and concealed laps cannot be confirmed.

Condition 2 - localised maintenance and repair required.

Arrange safe close-access inspection of membrane seams, plant kerbs, outlets and parapet flashings. Complete local patch repairs using compatible materials and record repaired areas on an updated roof plan.

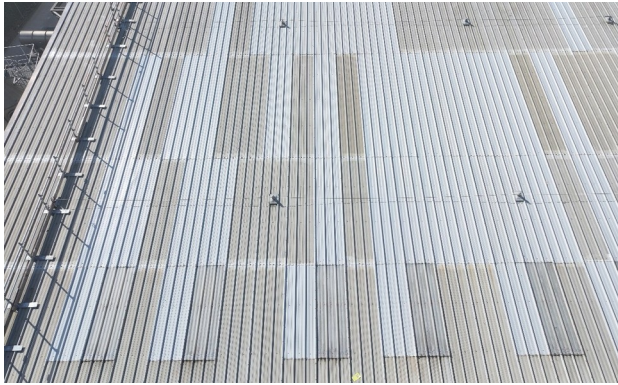
*Profiled rooflight runs showing contamination, ageing and variable light transmission.*

- Profiled metal roof sheets appear broadly aligned, with no widespread displacement visible from the aerial images.
- Rooflights show age-related discolouration and contamination, reducing natural light transmission.
- Local coating breakdown and corrosion are visible at selected sheet laps and fixings.
- Rooflights and adjoining sheets should be treated as fragile unless confirmed otherwise by competent assessment.
- Previous localised repairs may require monitoring to confirm durability.

Condition 2 overall, with selected high-priority defects requiring timely investigation.

Undertake safe close-access inspection of sheet laps, fixings and rooflight perimeters. Treat exposed cut edges using a compatible system and replace rooflight sheets where brittleness, cracking or failed joints are confirmed.

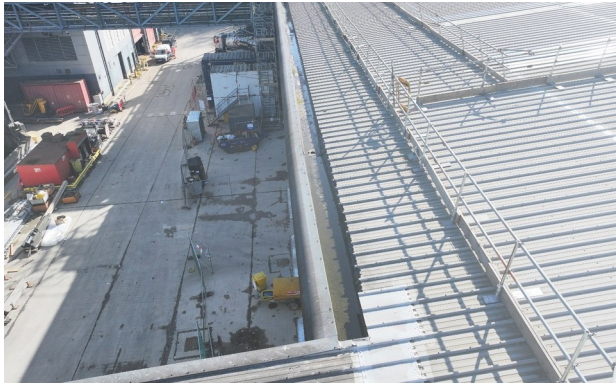
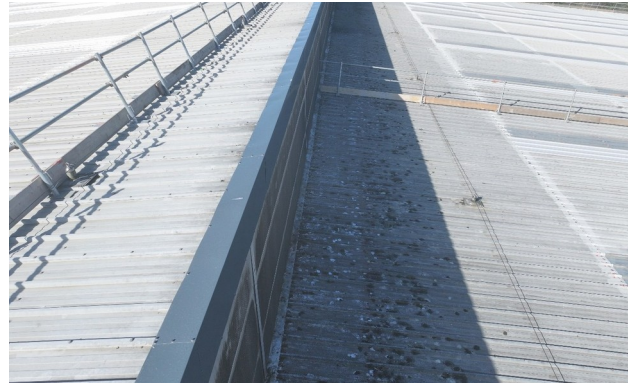
*Perimeter gutter and adjoining roof junction reviewed for debris and drainage restrictions.*

*Long gutter run requiring routine clearance and outlet inspection.*

- Debris and organic matter are present within selected gutter runs and sheltered drainage zones.
- Long commercial gutter runs are vulnerable to local blockage where outlets are infrequent or difficult to access.
- Standing debris can retain moisture and accelerate corrosion at joints, outlets and abutments.
- Rainwater goods should be checked for secure fixings, leakage at joints and discharge away from the building.
- No water-flow test was undertaken as part of this visual survey.

Condition 2 - maintenance required.

Clear gutters and outlets, remove vegetation, inspect joints and verify that discharge routes are unobstructed. Introduce a documented inspection schedule at least twice yearly and after severe weather.

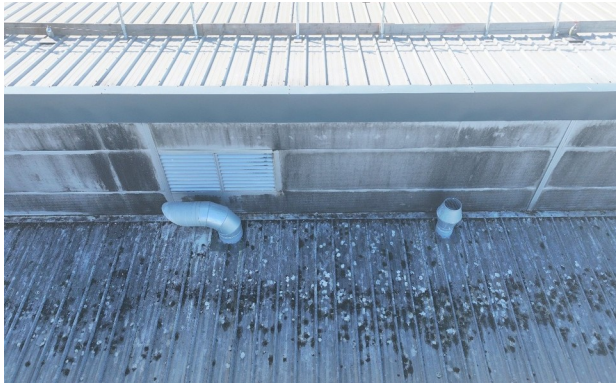
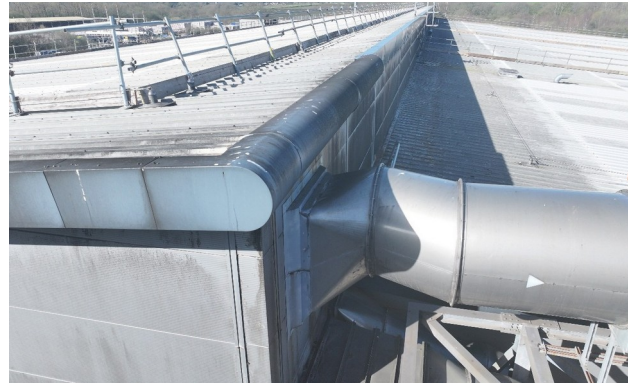
*Roof penetrations and adjacent contamination requiring close-access review.*

*Raised capping and adjoining ductwork showing multiple weathering interfaces.*

- Roof-mounted plant and services create multiple penetrations, kerbs and flashing interfaces.
- Local sealant ageing and weathering are visible at selected joints.
- Debris and contamination in sheltered zones may retain moisture against roof surfaces.
- Fasteners, washers and lap seals cannot be fully assessed from aerial imagery alone.
- No obvious major displacement was visible, but concealed joint condition remains unconfirmed.

Condition 2 - targeted repairs and routine monitoring required.

Inspect plant kerbs, flashings, penetration seals and capping joints from safe close access. Renew failed sealants with compatible products, remove debris and record each penetration within the roof asset register.

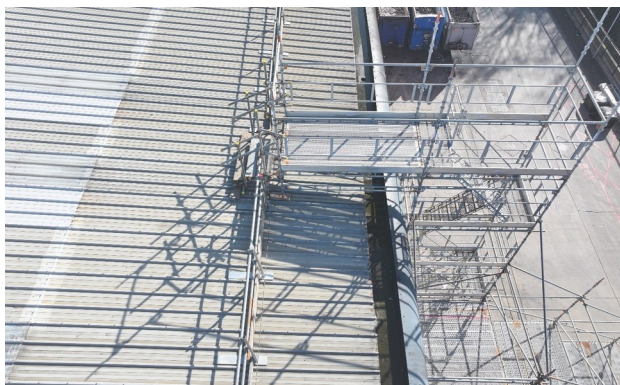
Temporary access arrangement beside a commercial roof edge.

Fixed ladder and roof-level access arrangement within a restricted zone.

- Access is constrained by multiple roof levels, operational areas and roof-mounted services.
- Fragile rooflights and potentially fragile sheets require clearly defined safe routes.
- Visible fall-protection equipment must not be assumed safe without current specialist certification.
- Any planned work requires task-specific access, edge protection or restraint, and an emergency rescue plan.
