# CUNNINGHAM ROOF SURVEYS

# RESIDENTIAL ROOF SURVEY

| Report reference | CRS-SAMPLE-RES-001 |
| Status | Illustrative website sample - not for reliance |

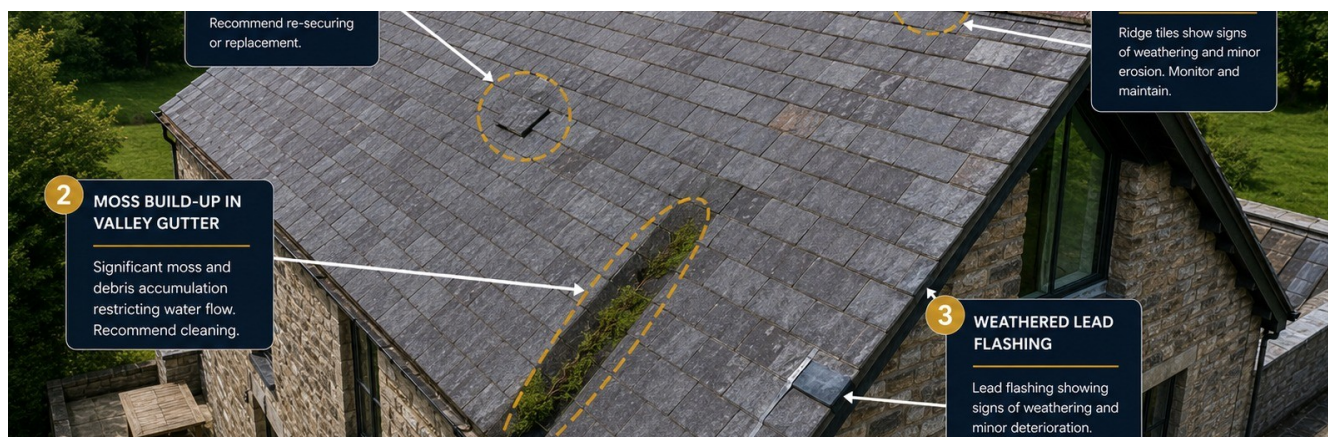
*Illustrative annotated aerial image showing how residential findings may be referenced in a live CRS report.*

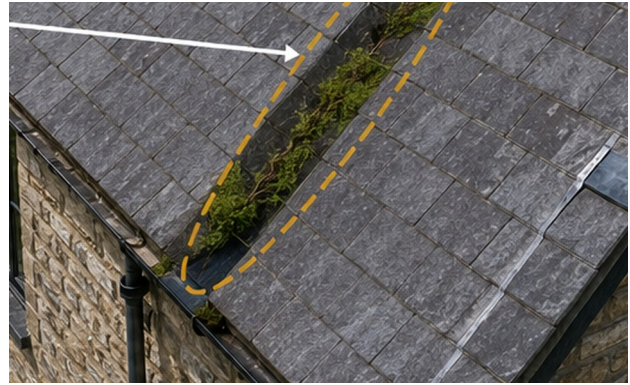
*Drone-assisted review used to reduce unnecessary access onto pitched roof surfaces.*

- Roof junctions and visible penetrations create local interfaces that require periodic inspection and compatible weathering details.
- Local sealant ageing and surface weathering may be present at selected junctions and should be checked from close access.
- Verge, eaves and fascia details appear generally serviceable but require routine cleaning and maintenance.
- Fasteners, concealed membranes and hidden junctions cannot be fully assessed from aerial imagery alone.
- No obvious widespread failure was visible, but concealed water paths remain possible where defects are intermittent.
